**ENVIRONMENTAL SITE ASSESSMENT
FOR THE
EVALUATION OF POTENTIALLY
HAZARDOUS MATERIALS**

*Vacant area
8314 Parkhurst Dr.
Houston, Texas 77093*

City of Houston
Building Services Department
P.O. Box 1562
Houston, Texas 77251

RAO ENVIRONMENTAL
19333 Hwy. 59 North, Suite 190
Humble, Texas 77338

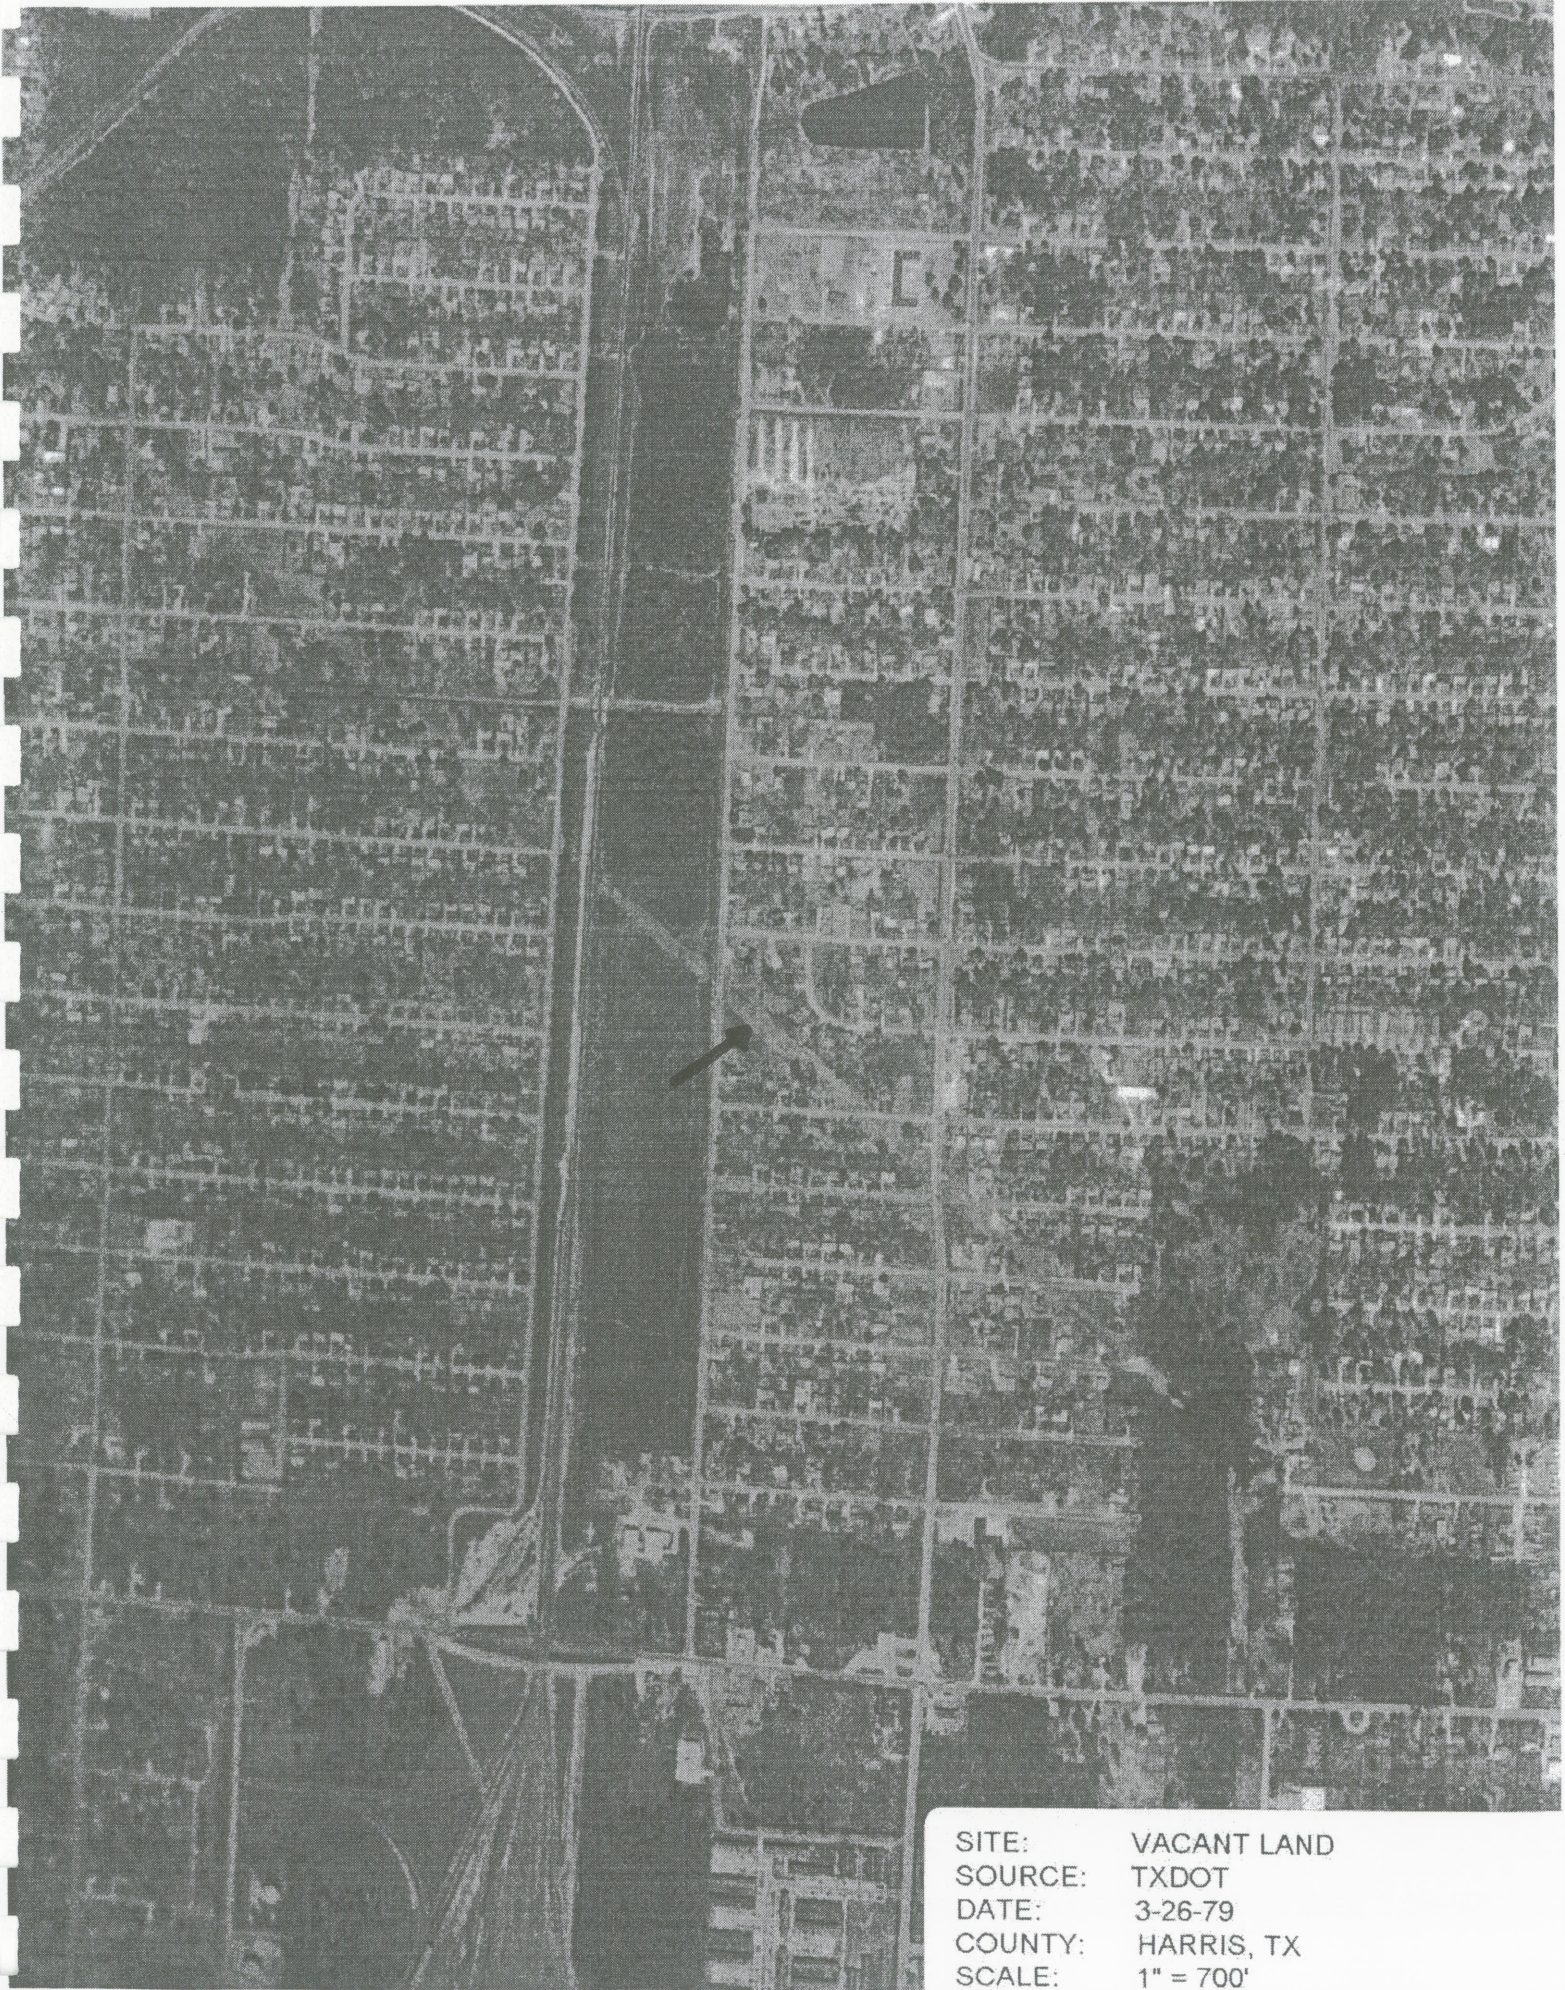
1979 aerial photo (1"= 700 ') shows the site as a vacant land. Vacant, residential and commercial sites are present to the far north, south, east and the west.

SITE: VACANT LAND
SOURCE: TXDOT
DATE: 3-26-79
COUNTY: HARRIS, TX
SCALE: 1" = 700'

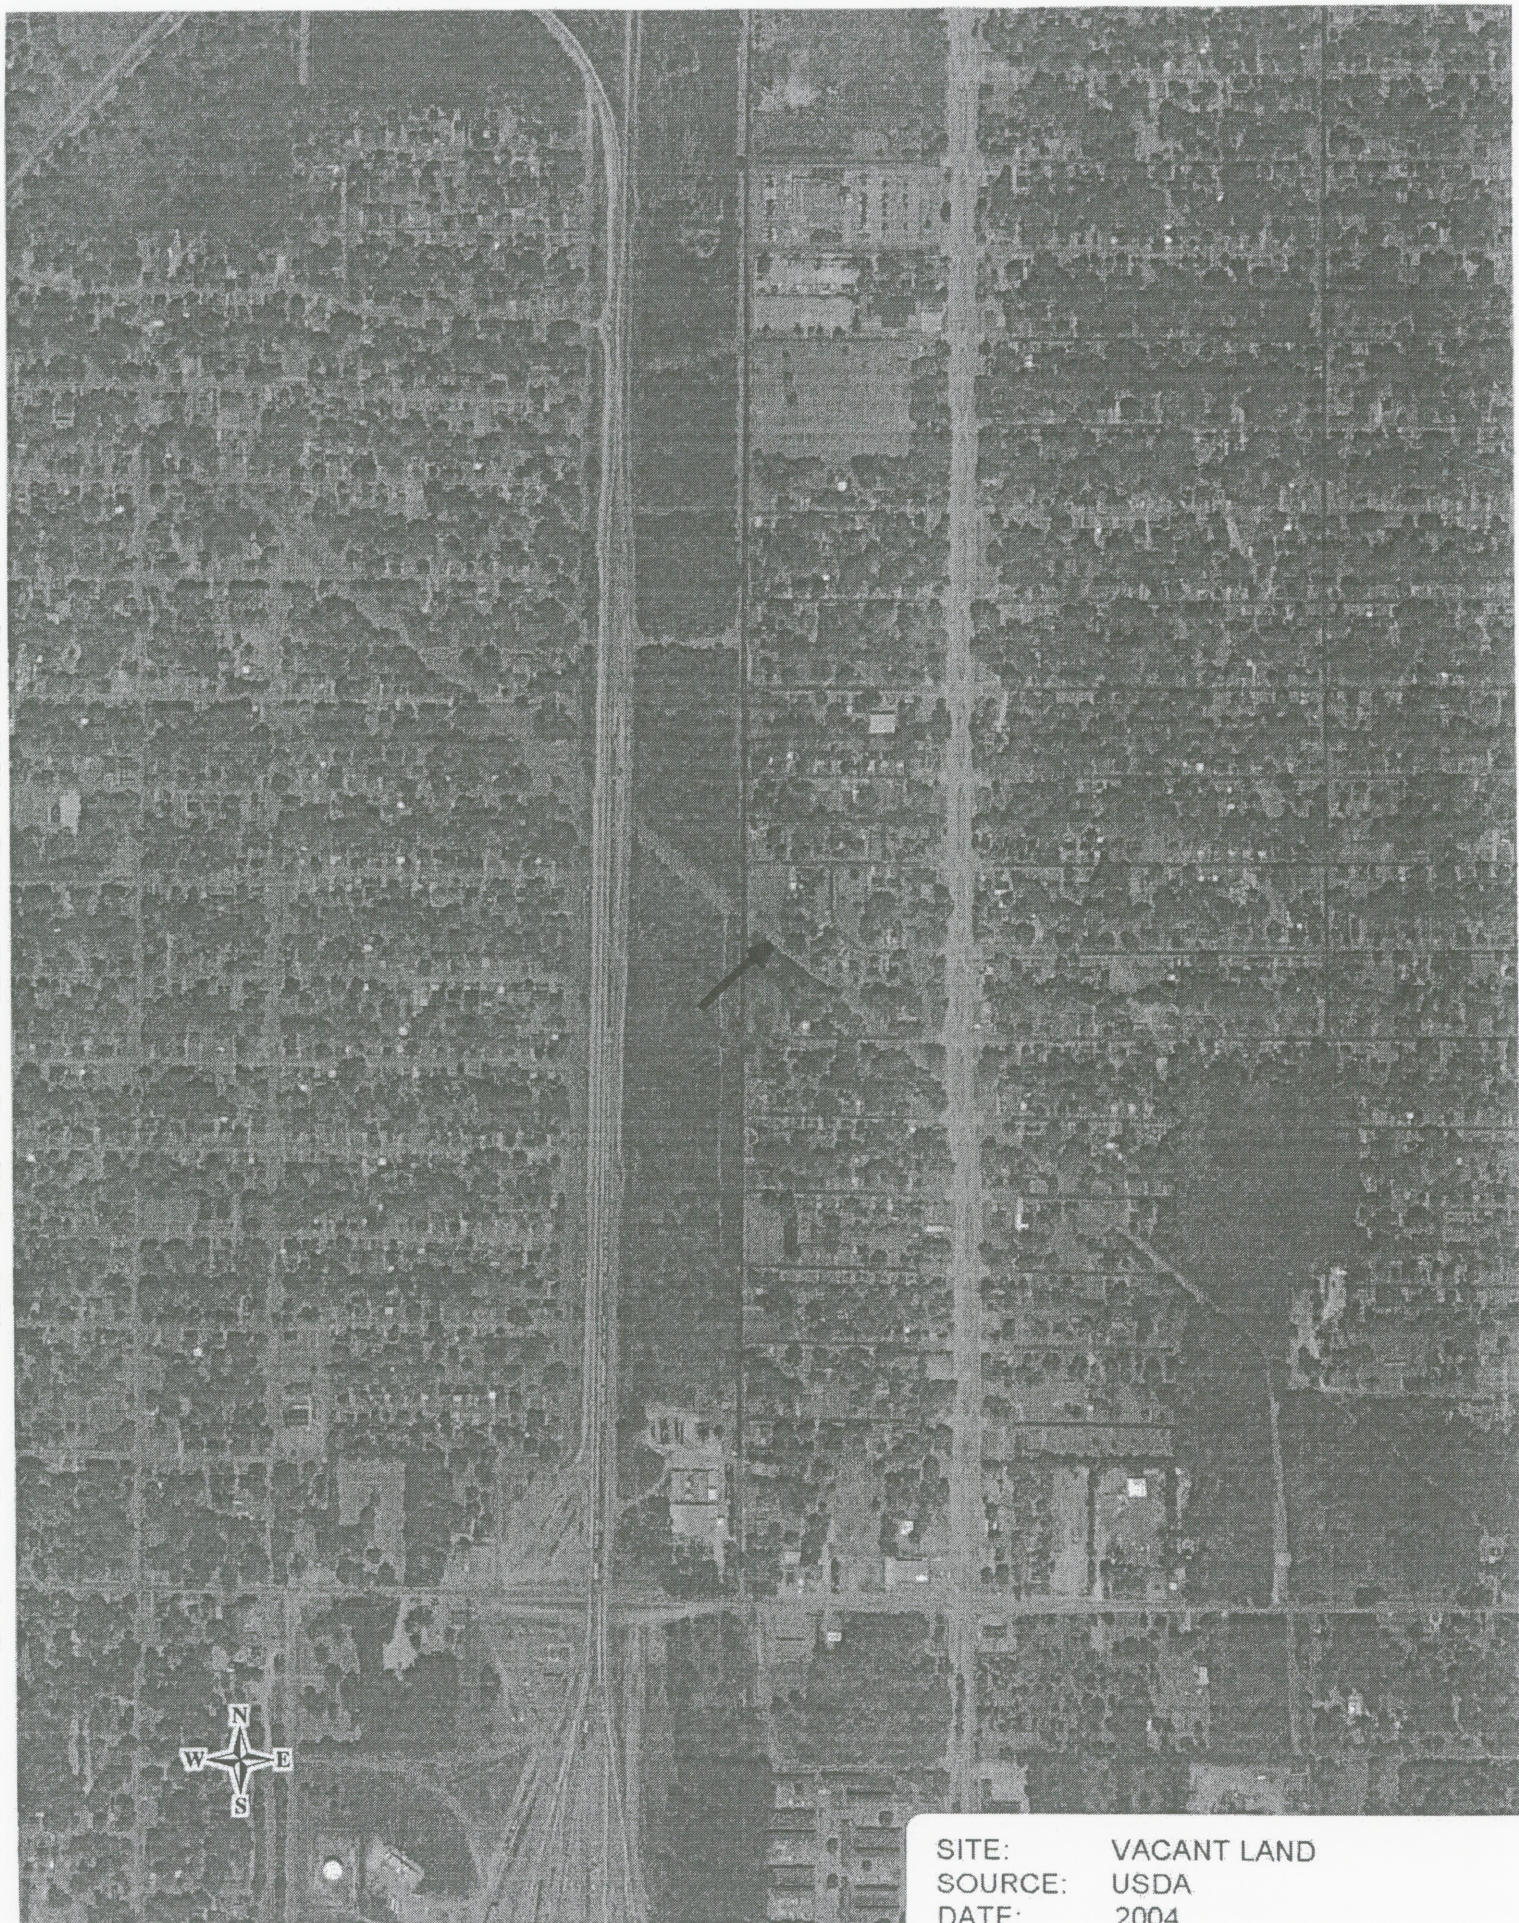
2004 aerial photo (1"= 700 ') shows the site as a vacant land. Vacant, residential and commercial sites are present to the far north, south, east and the west.

SITE: VACANT LAND
SOURCE: USDA
DATE: 2004
COUNTY: HARRIS, TX
SCALE: 1" = 700'

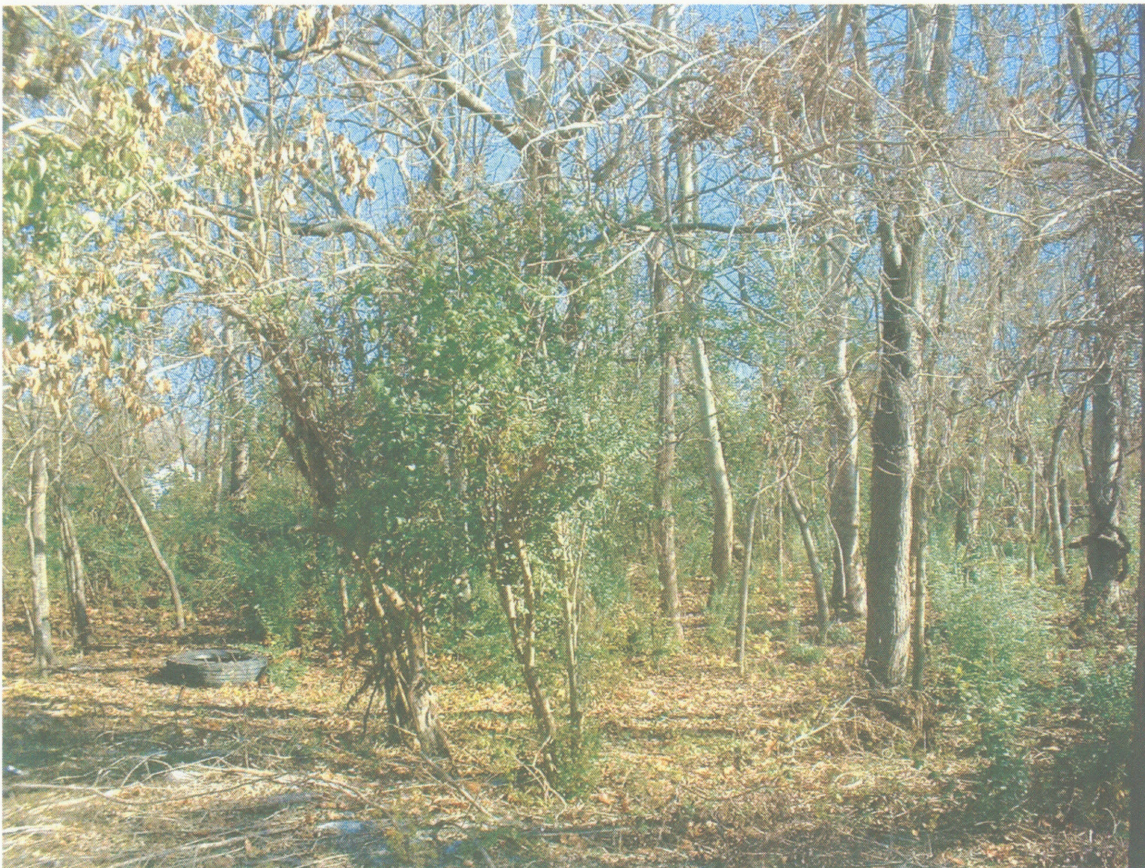
The subject property is a vacant land and is 9,900 square feet in area. The site has vacant, grass covered areas with weeds and trees. Entrance to the site is from Parkhurst Dr. A partial fence of a house is present to the east of the site. A pipeline easement area was found along the northern boundary of the site. The pipeline easement consists of EXXON mobile products pipeline, two TEPPCO petroleum pipelines, CITGO products pipeline, Entex gas pipeline and natural gas pipeline of Mobil Vanderbilt-Beaumont pipeline. No other developments or improvements were found at the site.

Subject site

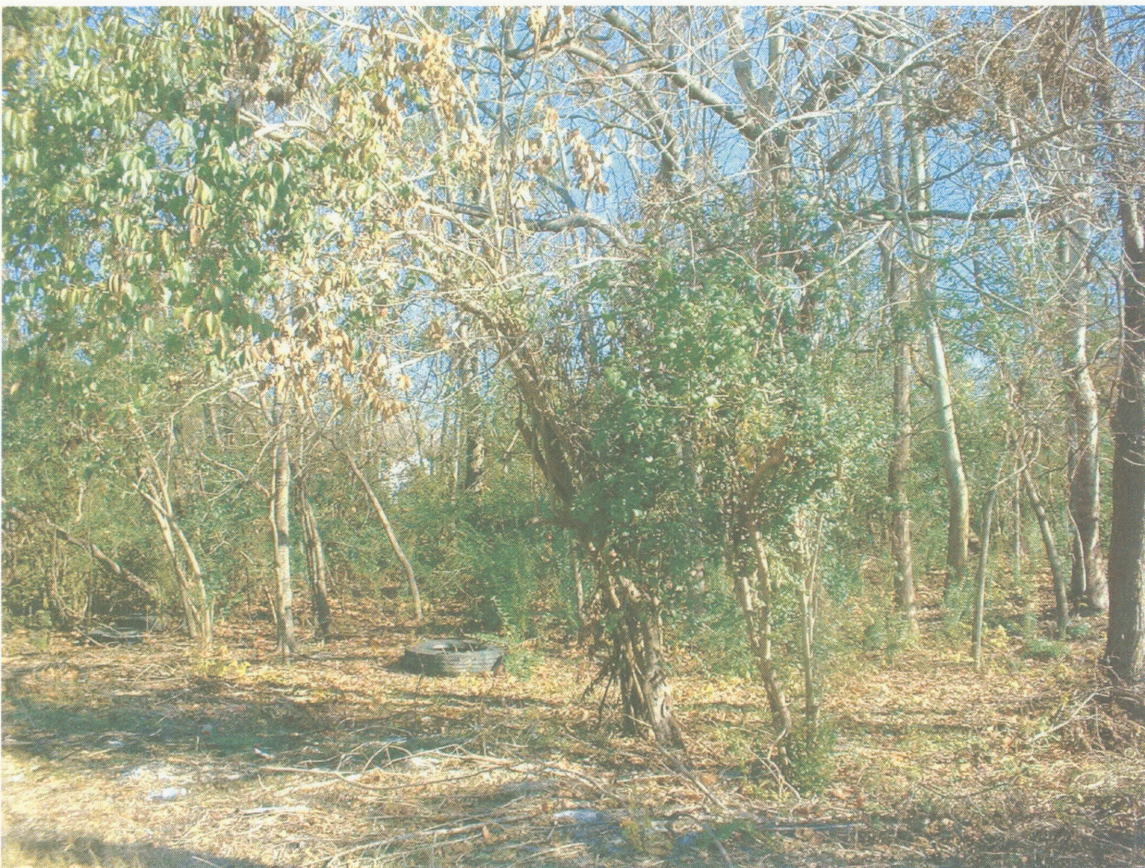
Dense trees at the property

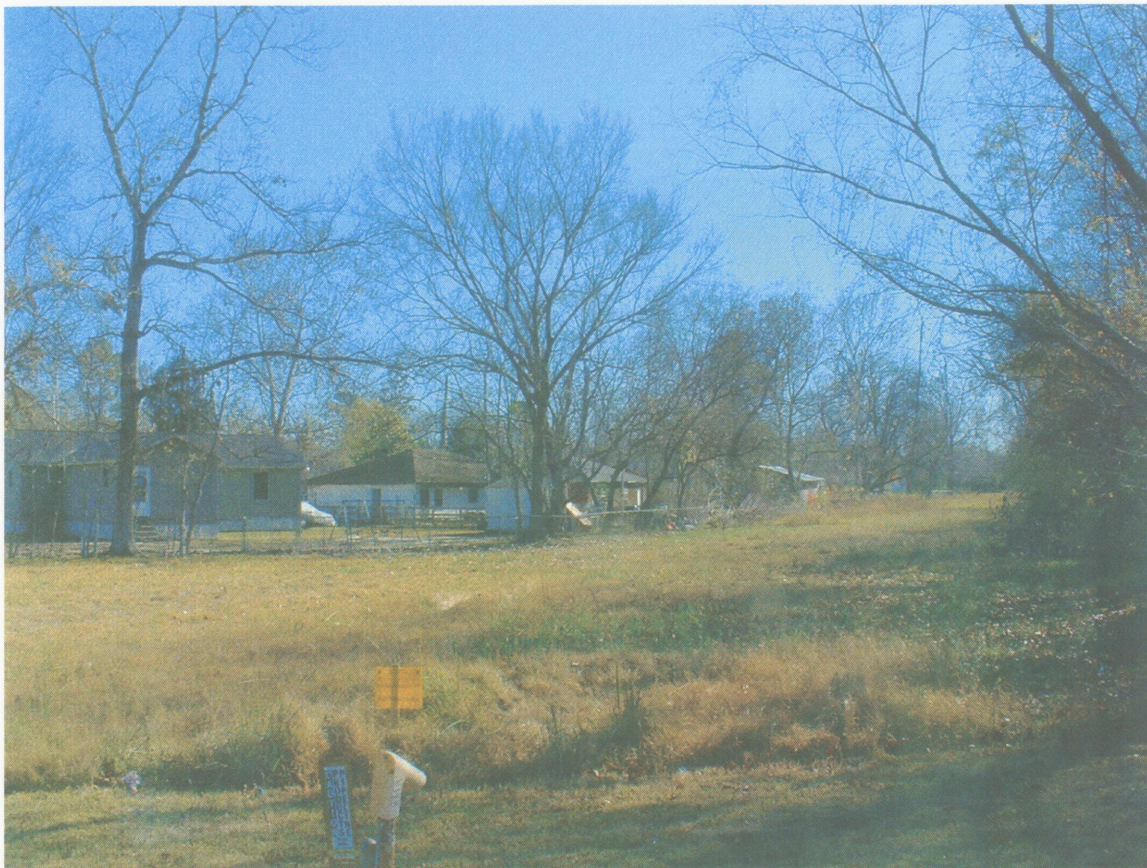
Property usage-north: Adjacent properties to the north are pipeline easement area, vacant grassy area, Linda Vista Rd. and a residential area.

Sites to the north

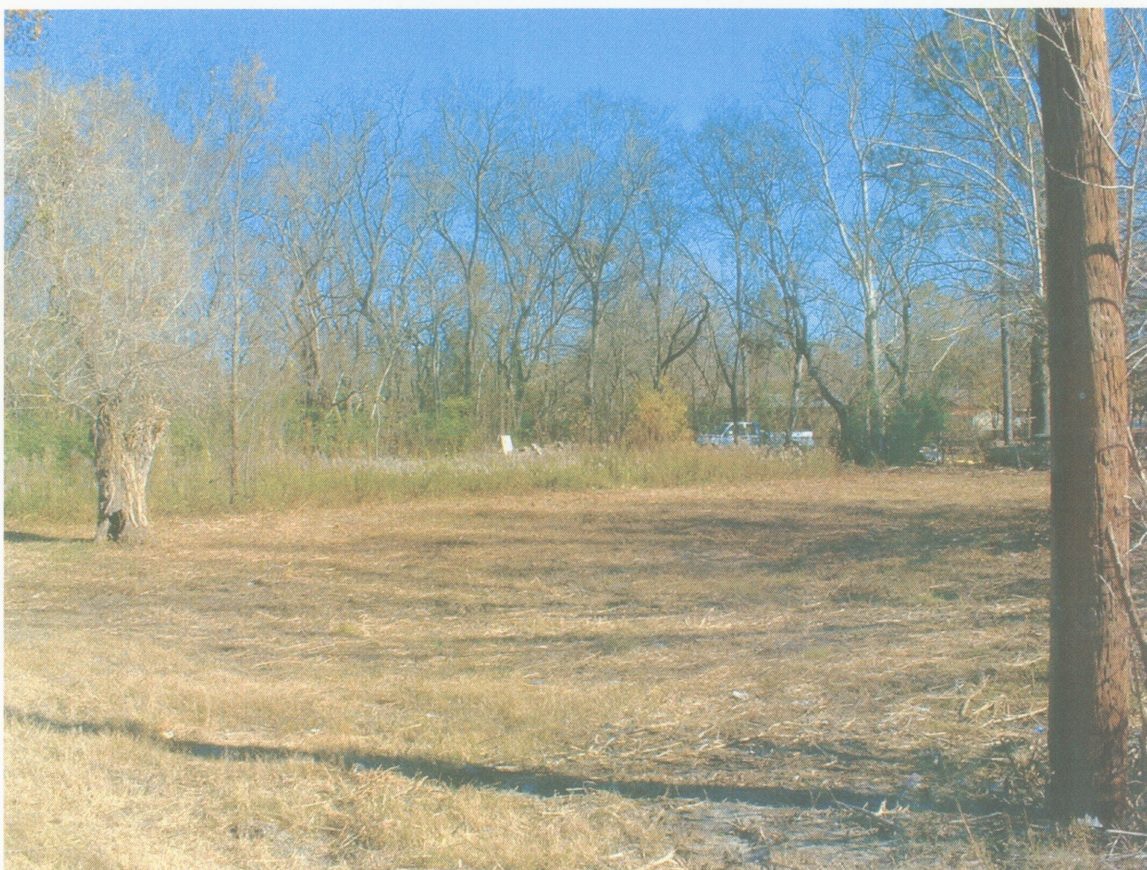
Property usage-south: Adjacent properties to the south are vacant land with weeds, bushes, grass, Crestview Dr. and a residential area.

Sites to the south

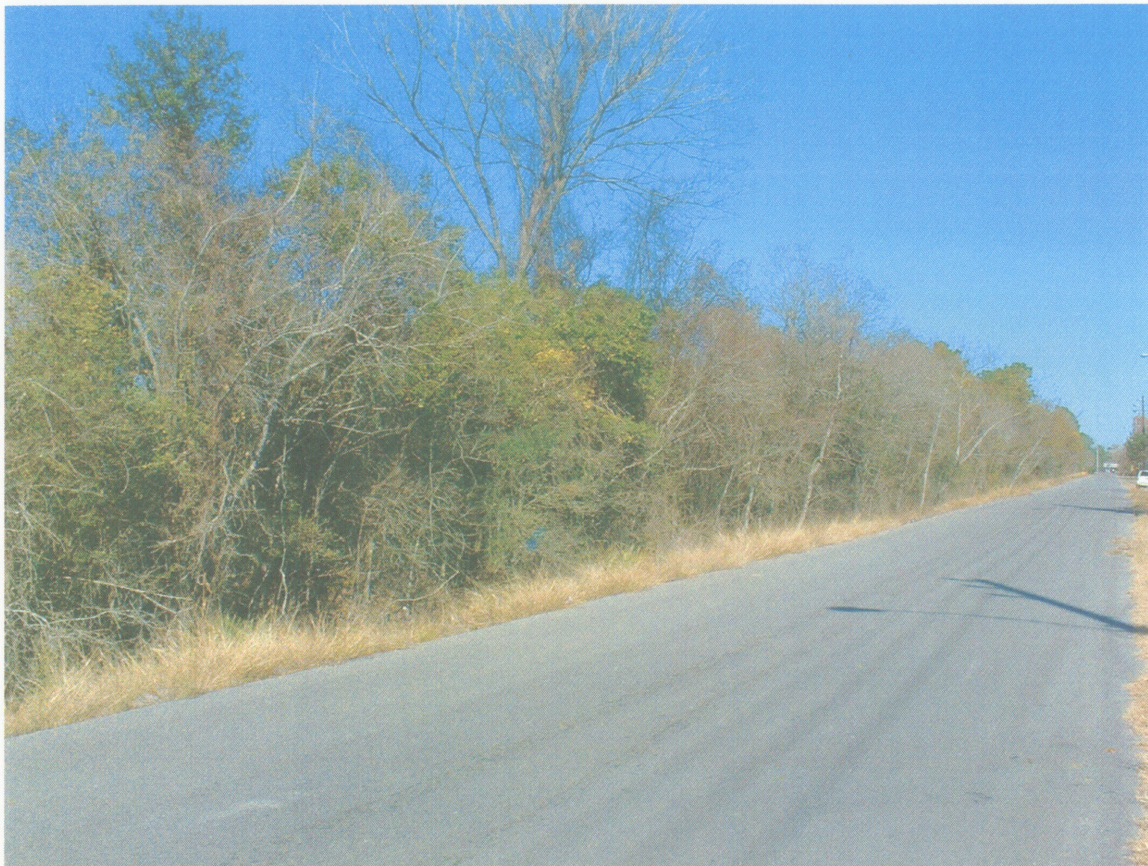
Property usage-west: Adjacent properties to the west are Parkhurst Dr., area with dense trees and railway track.

Sites to the west

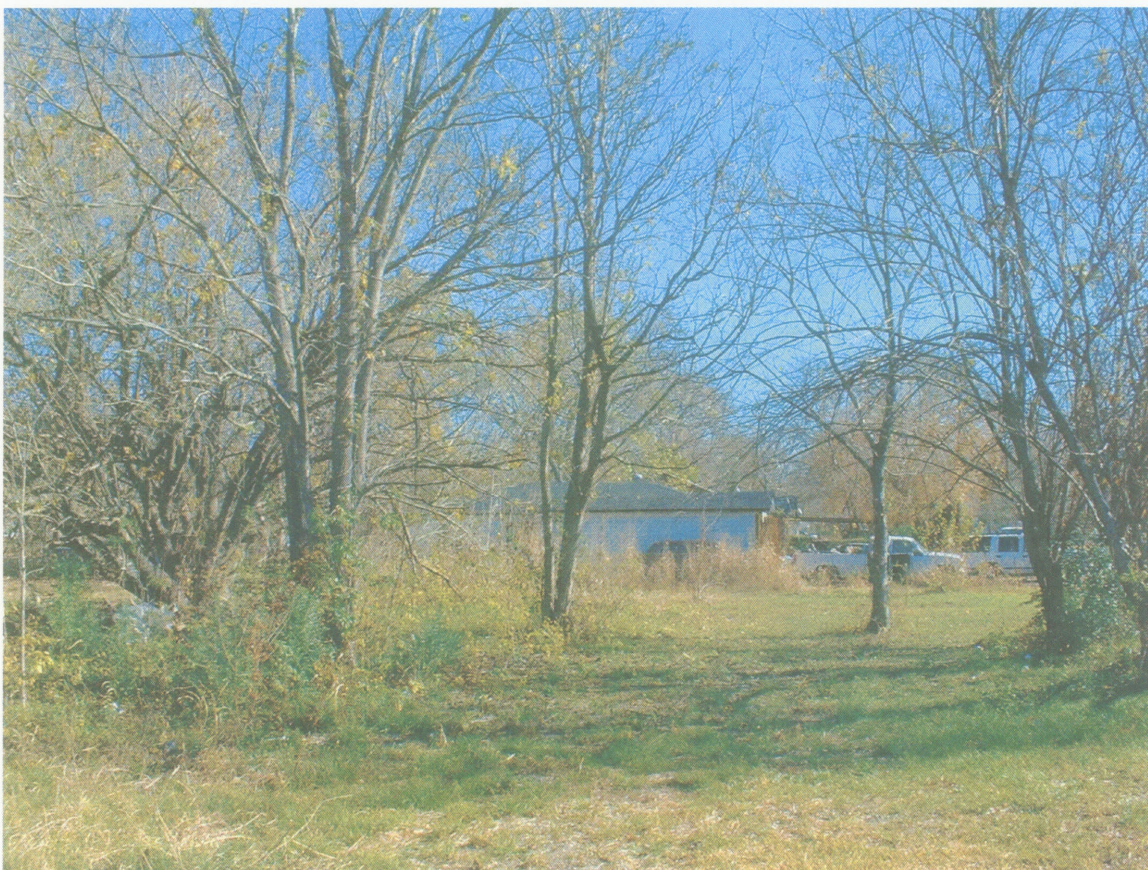
Property usage-east: Adjacent property to the east is a residential area.

Sites to the east
